ISSUE 36

Newsletter Date 12/01/2014

BFD Times

Coffee Break Training - Fire Protection Series

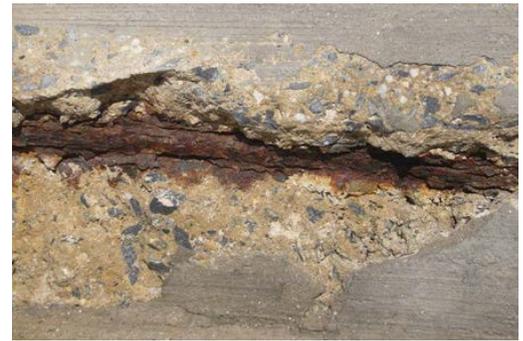
The concrete that once protected this steel reinforcing bar has spalled, exposing the reinforcement to the elements, including the heat from a fire.

Concrete in building construction is subject to a condition called spalling. "Concrete spalling is usually caused by corrosion of the steel reinforcement bars embedded in the concrete matrix, but can be caused by other ferrous elements either fully or partially embedded in the structure. Steel frame window systems, handrails, structural I-beams, metal pipes and conduits are among the most common of the damage causing building components. Corrosion of the reinforcement steel however, is by far the most common cause of spalling and splitting in older concrete structures."

In addition to affecting the building's structural integrity, the consequences of spalling that exposes steel reinforcement materials have a potential fire safety consideration as well. The exposed steel is highly susceptible to damage from increased heating, further weakening the structure and increasing the risk of catastrophic failure.

When inspections or pre-incident planning reveals reinforced concrete with exposed steel, steps should be taken by a qualified person or company to repair the problem. These steps include:

1. Determining the cause and extent of deterioration. The cause of the problem should be thoroughly investigated to prevent a recurrence.
2. Identifying the repair objectives. While restoring structural integrity and durability are important safety concerns, the building owner may be equally concerned about leakage control and improving aesthetics.

3. Giving consideration to the environmental and logistical limitations to making the repairs. Depending upon the scale of damage, the repairs likely cannot be accomplished in a single work period.

4. Evaluating the need for temporary support and shoring. The extent of damage may be so severe that isolating the problem and providing support and shoring may be required.

5. Selecting the appropriate repair materials. The materials and method must be approved for the existing configuration to ensure the repairs remain in place.

6. Repairing the steel that was damaged by exposure. Steel that has been exposed likely has been weakened and should be repaired to match its original strength.
